MOUNTAIN SHADOW LAKE DAM

NDI ID NO. PA-00244
DER ID NO. 19-80

PHASE I INSPECTION REPORT NATIONAL DAM INSPECTION PROGRAM

PHASE I INSPECTION REPORT

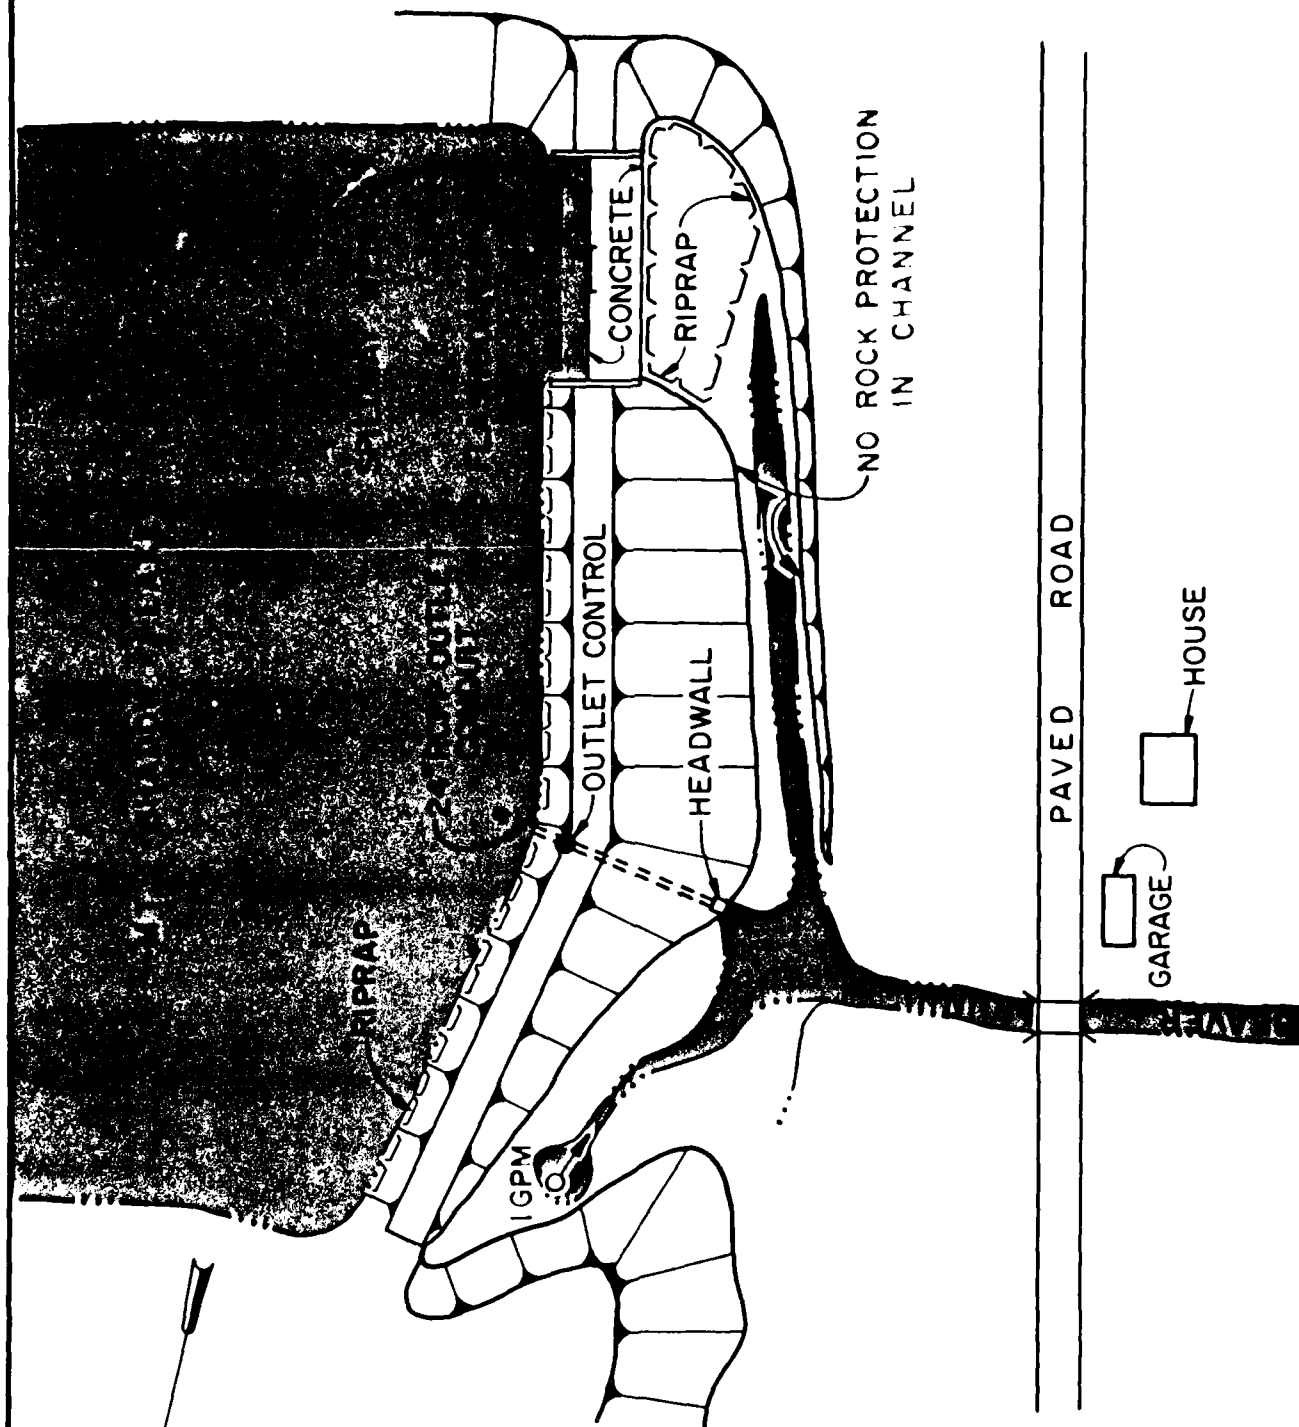
EXHIBIT A-1

None observed. One gpm coming from hillside 20 feet d/s right abutment; source is apparently springs since another spring is about 50 feet away.

Riprap on upstream face in good condition. Riprap in spillway discharge channel adjacent to toe of dam has been recently pushed out of channel bottom and against left bank.

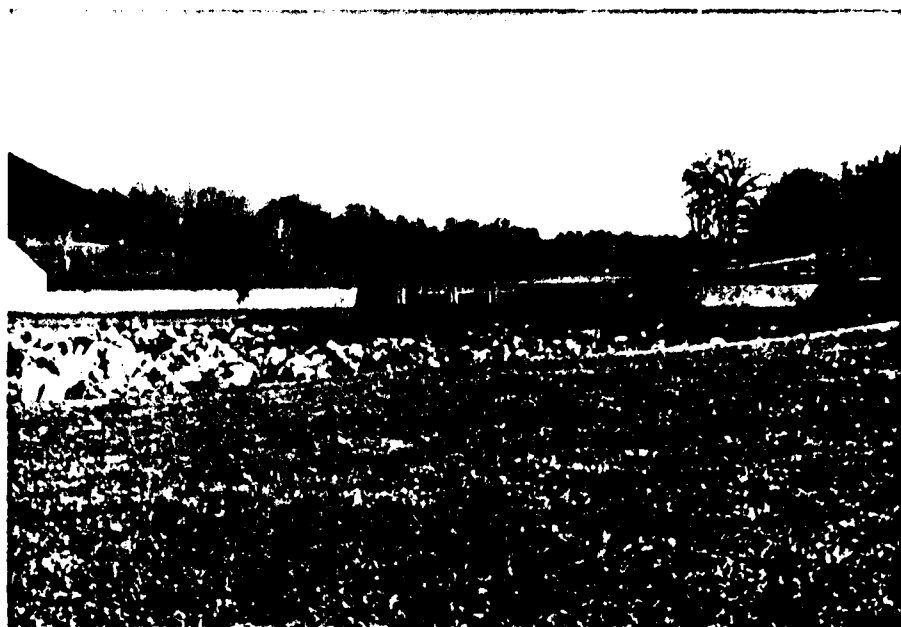
Rock in good condition in upper part immediately downstream of spillway slab. Channel bends to right, narrows and parallels toe. Rock has been pushed out of channel bottom and from toe of dam to provide protection for left bank of channel.

6. Spritlock cut and open part of discharge channel.

1. The owner should restore the riprap protection for the spillway discharge channel to design condition without delay.

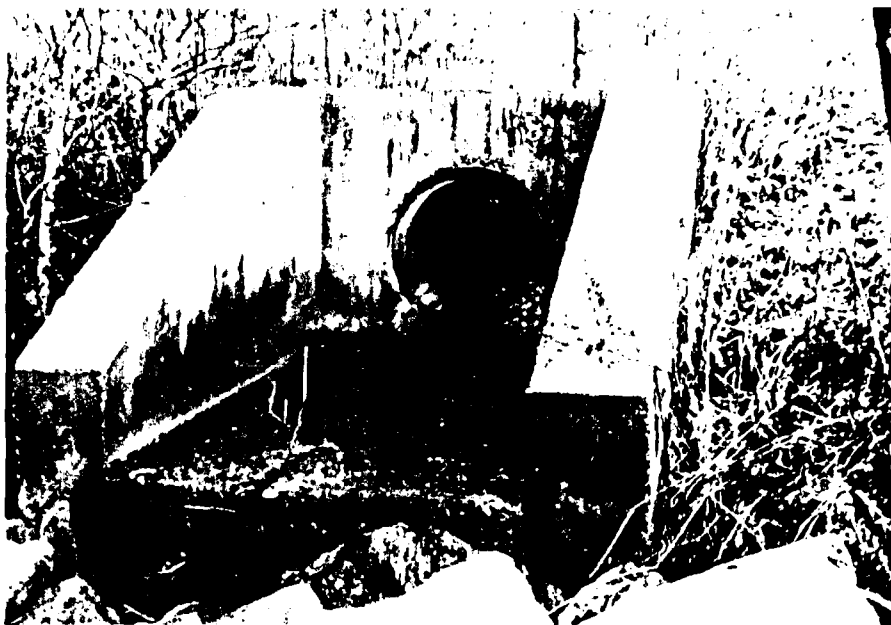
9. Downstream end of outlet conduit and headwall.

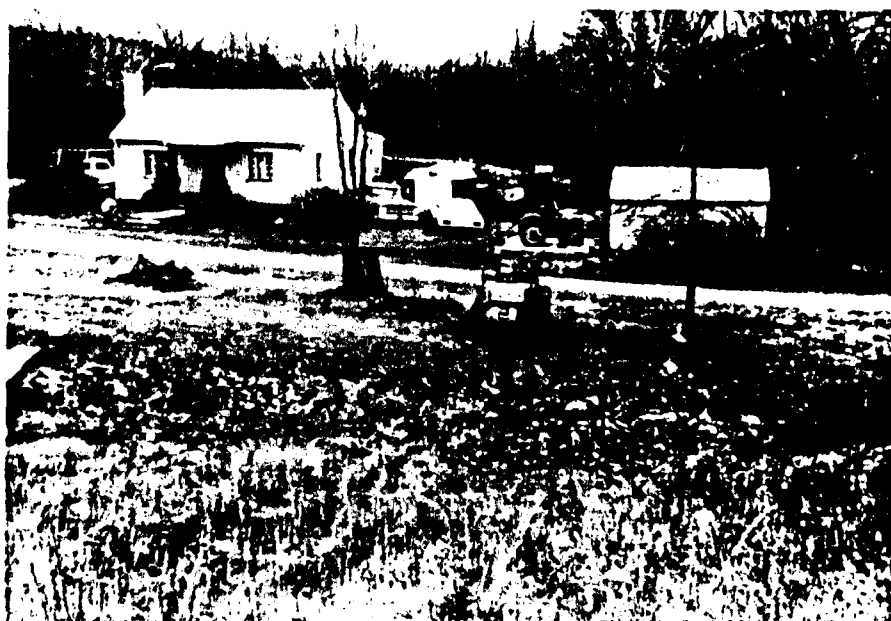
10. Downstream hazard area from top of embankment.
